Condition Monitoring of distribution transformer: A case study on 500 kVA distribution transformer of Jigme Namgyel Engineering College (JNEC) using Thermal Imaging method

Chenga Dorji^{1*} and Dileep G²

¹⁻² *Jigme Namgyel Engineering College, Royal University of Bhutan*

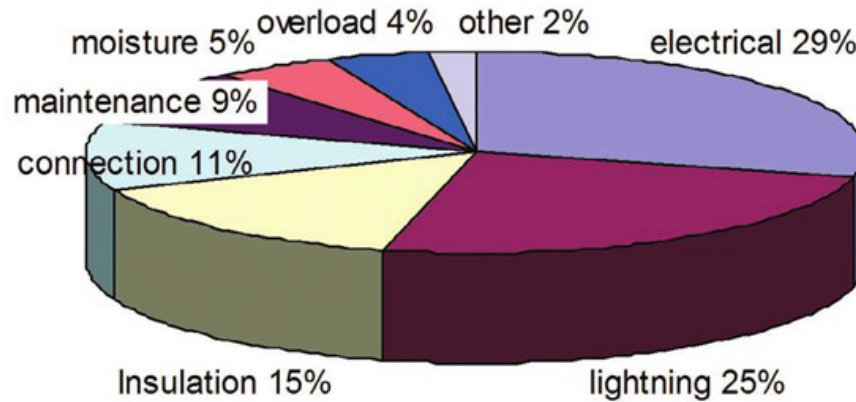
A detailed analysis of distribution transformer failures reveals several key contributing factors, with electrical issues emerging as the most significant, accounting for 29% of failures. This category includes winding faults, short circuits, and voltage stresses, all of which place undue electrical stress on transformer components. Lightning strikes are the second leading cause at 25%, as high-voltage transients from lightning can severely damage insulation systems. Insulation failures represent 15% of failures and are typically caused by thermal stress, material aging, or contamination, leading to reduced dielectric strength and eventual breakdown. [1]

Figure 1: % wise distribution of causes faults in distribution transformer [1]

Connection problems contribute to 11% of failures, emphasizing the importance of proper installation and maintenance. Loose or corroded terminals can lead to localized heating and mechanical degradation. Maintenance-related issues, comprising 9%, underscore the need for regular upkeep such as monitoring oil levels, cleaning breathers, and addressing minor issues before they escalate. Moisture ingress, responsible for 5% of failures, contaminates insulating oil and degrades solid insulation, increasing the risk of electrical discharge [1]. Overloading accounts for 4% of transformer failures, as operating beyond rated capacity generates excess heat, accelerating insulation deterioration and potentially damaging windings [1]. The remaining 2% is attributed to other less frequent or uncategorized causes. This breakdown highlights that electrical faults, lightning surges, and insulation degradation are the primary drivers of transformer failure. Enhancing transformer reliability therefore requires robust electrical design, effective surge protection, the use of high-quality insulation materials, secure electrical connections, consistent maintenance practices, and avoiding the overloading conditions.

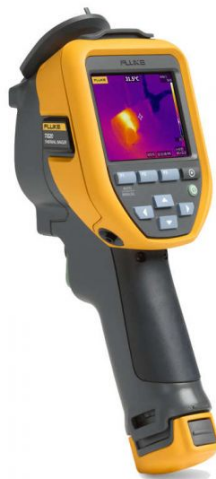
Figure 3: Fluke TiS75+ Thermal imager

Thermal images were captured under normal load conditions using a *Fluke TiS75+* thermal imager (infrared resolution: 384×288 pixels [110,592 pixels]; accuracy: ± 2 °C or $\pm 2\%$ of the reading, whichever is greater, at an ambient temperature of 25 °C), as shown in Figure ??, to ensure accurate thermal signatures.

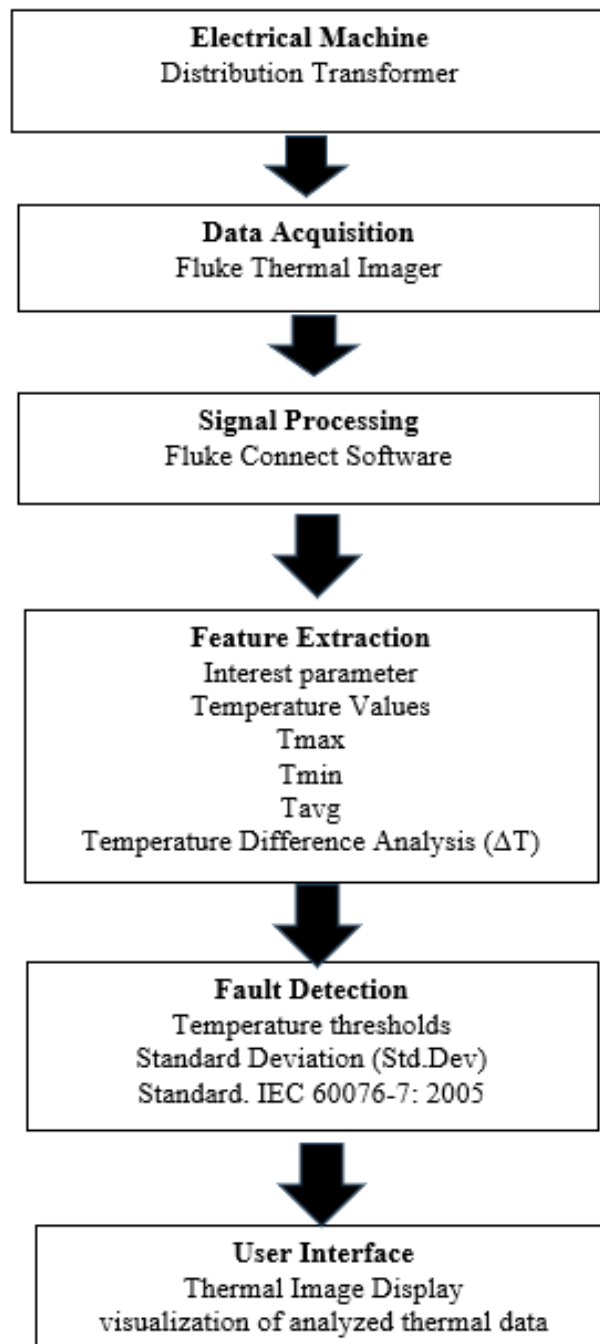
Analysis of thermal data was carried out to derive key diagnostic metrics, as demonstrated in Figure 4. This comprised the extraction of point and area temperatures, capturing minimum, maximum, and average values to analyze thermal performance across components. Temperature differences were determined by comparison of localized component readings with ambient conditions, allowing the location of potential overheating or inefficiencies. Moreover, thermal patterns were inspected to detect anomalies and uneven heat distribution that may show underlying degradation or faults. Baseline measurements were methodically recorded to facilitate trend analysis and longitudinal comparisons in future inspections.

Figure 4: Methodology flowchart
